Inspection Report (PSI)

O-cn-1022355

Client Name:	Hebei Central Plumbing Industries		
	Product Name:	Ductile iron gate valve, Water Butterfly Check Valve, Centre Line Water Butterfly Valve		
	Inspection location:	Hebei		
	Your reference number:			
	P/O number:			
	Supplier:	Hebei Central Plumbing Industries		
	Order quantity:	787		
	Pcs ready for inspection:	787 (100%)		
	Reference sample available:	n/a

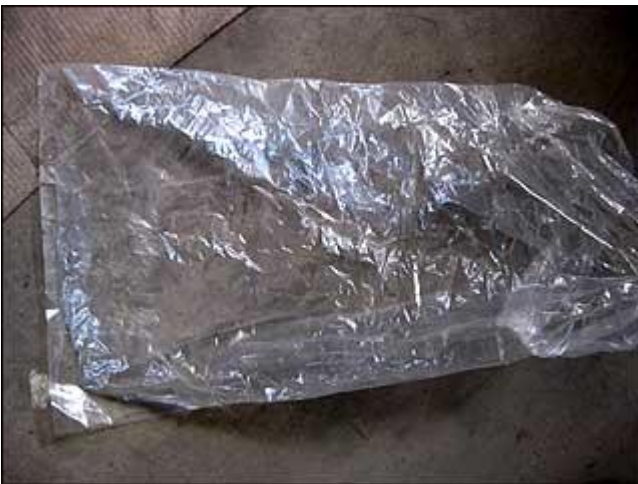
No punch holes on poly bag

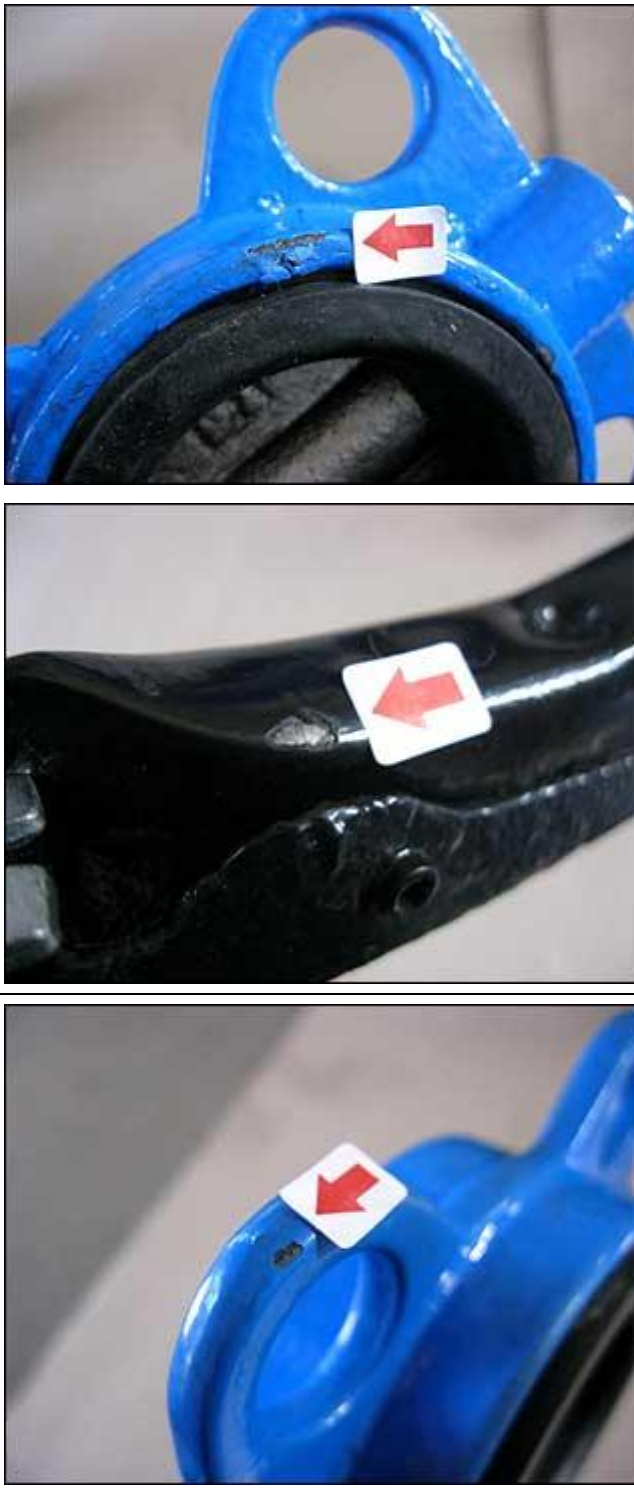
DEFECTIVES LIST					
		CRI	MAJ	MIN	Picture
	Peel off painting	0	6	0

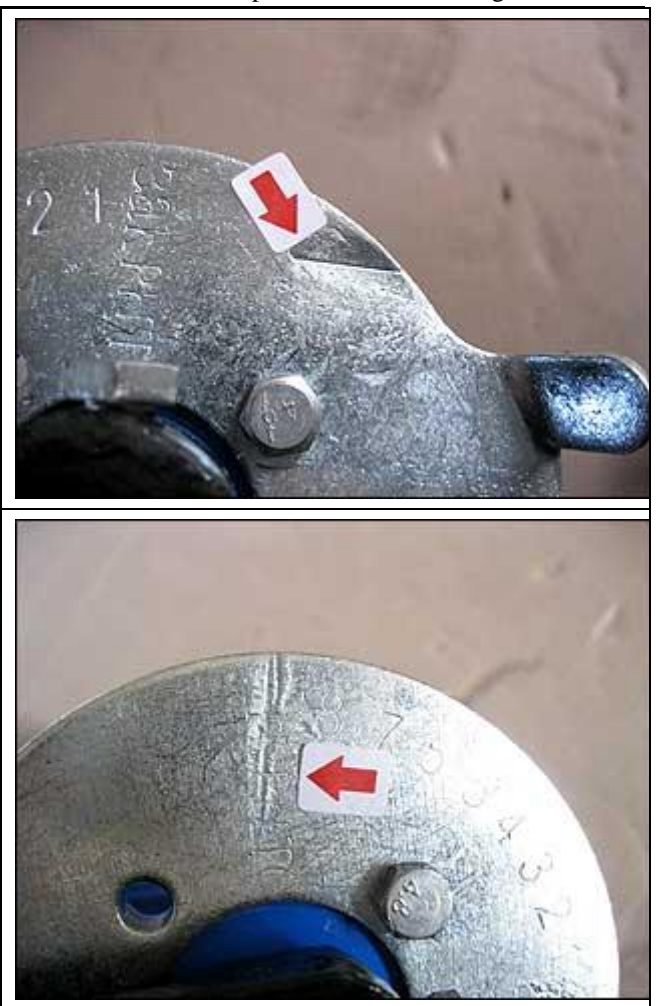
Cut mark	0	3	0

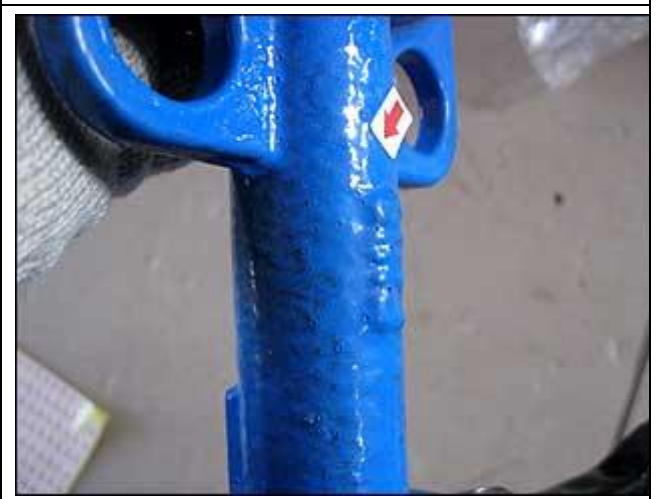
Poor coating	0	3	0
