www.Signalnspection.com	<h1 style="color: orange;">INSPECTION REPORT</h1>	Report Number :	Overall Result
		S-TJ-201105152	Failed

Client Name: Hebei Central Plumbing	
Inspection type : Pre-shipment Inspection	
Product Name: Water Butterfly check valve	
Inspection location:	Tian Jin
Supplier: Hebei Central plumbing Industries	
Po number : 14/15/16/17	
Item Number :	Ref to page 2
Order quantity:	1744pcs
Ready quantity:(%)	1744pcs
Reference sample available:	NO

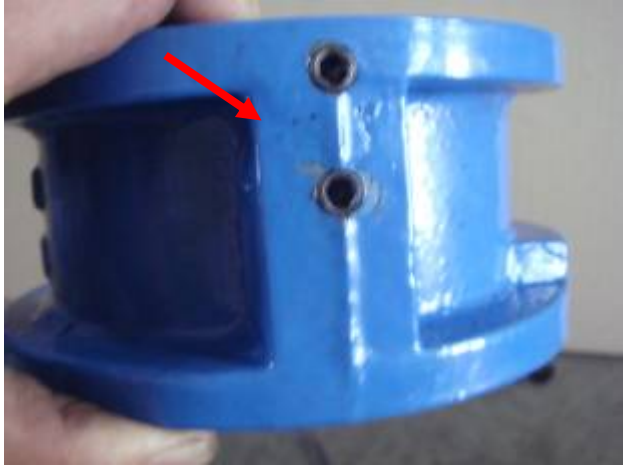
3. WORKMANSHIP DEFECTIVES LIST				
Defect Description	Critical	Major	Minor	Pictures
The paint peel off	0	0	2

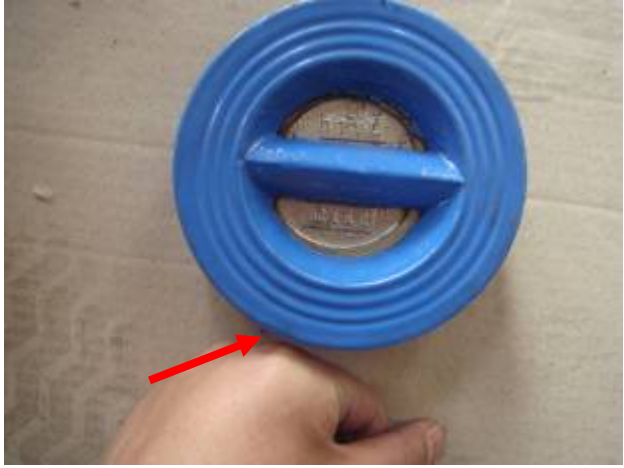
rough selvedge	0	0	1

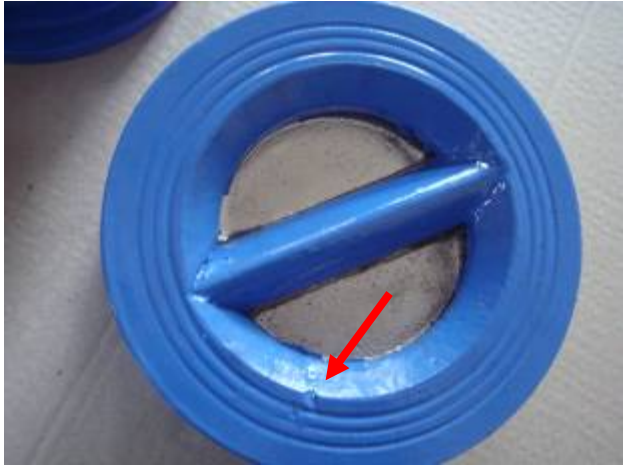
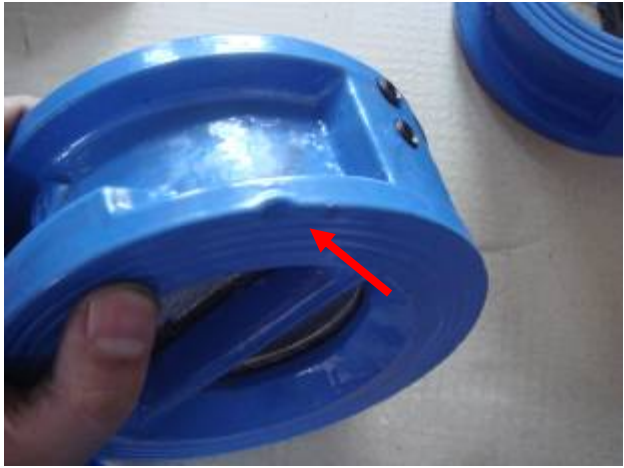
misrun	0	0	2

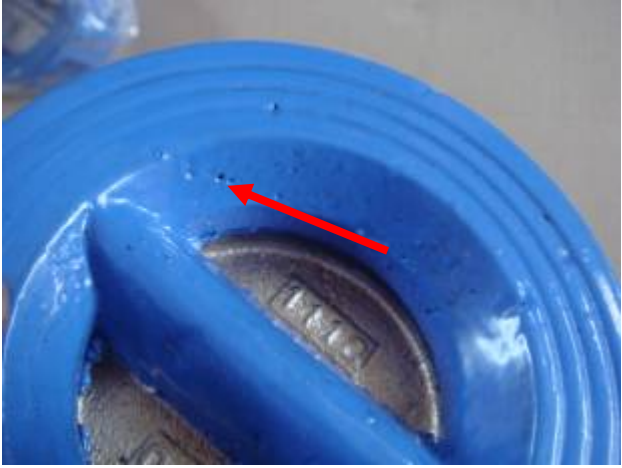
sand hole	0	0	2

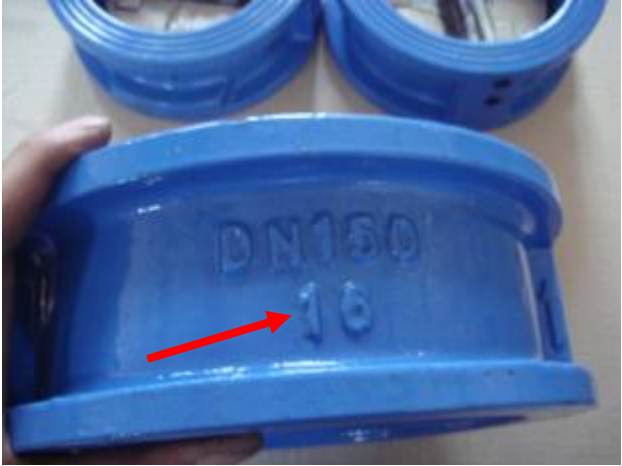
1. Products of the four orders were put together, inspector can't separate four order.
2. There is no PN (it should be PN16)marked on DN150.

No mark of PN (There is no PN (it should be PN16)marked on DN150.)	0	20	0

Specification	Result	Actual Finding
	Failed	no mark of PN on DN150

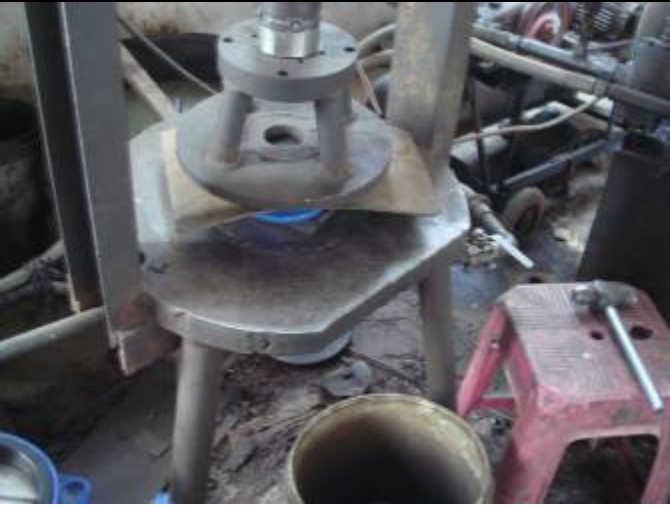
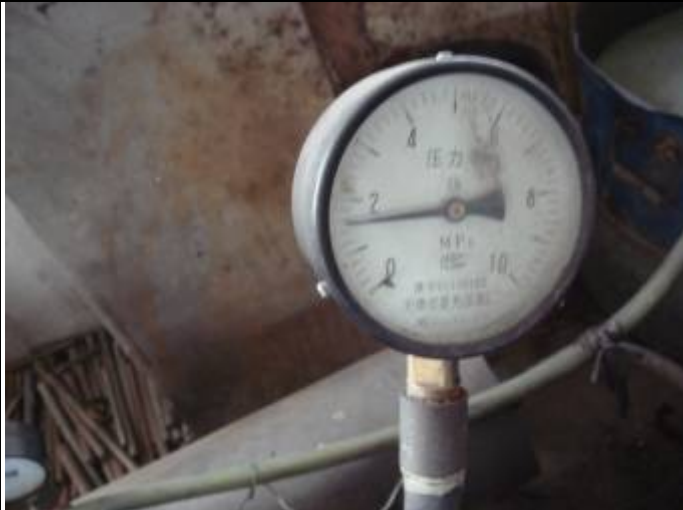
Test description		Specification	Result
F1	Hydraulic test	1 pc per item shell tightness test: 1.8Mpa/60s shell strength test: 2Mpa/120s	passed

shell tightness test		shell tightness test

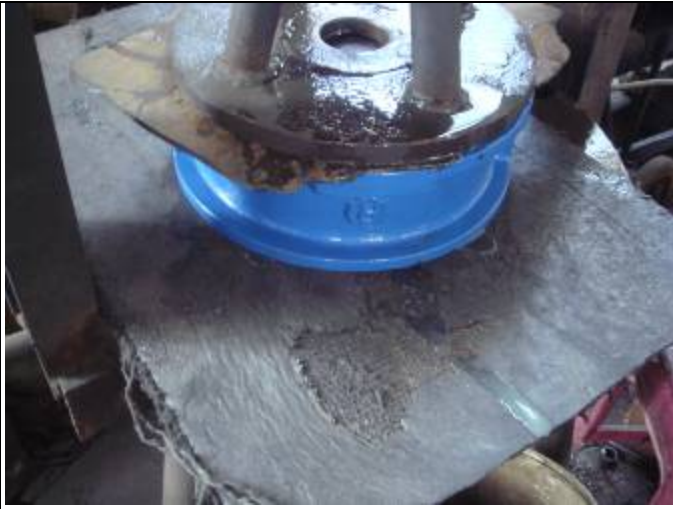
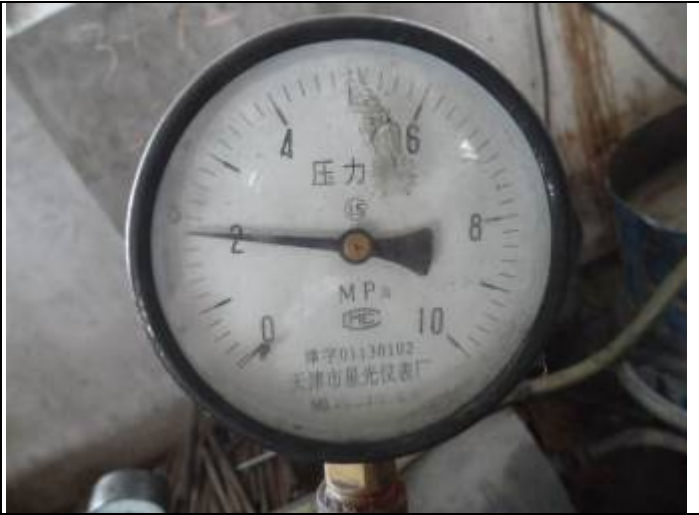
shell strength test
