Inspection Report (PSI)

O-cn-1022355

Client Name:	Hebei Central Plumbing Industries		
	Product Name:	Ductile iron gate valve, Water Butterfly Check Valve, Centre Line Water Butterfly Valve		
	Inspection location:	Hebei		
	Your reference number:			
	P/O number:			
	Supplier:	Hebei Central Plumbing Industries		
	Order quantity:	787		
	Pcs ready for inspection:	787 (100%)		
	Reference sample available:	n/a

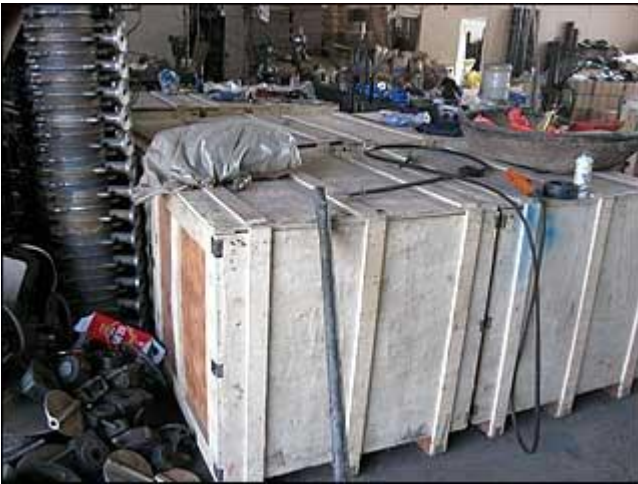
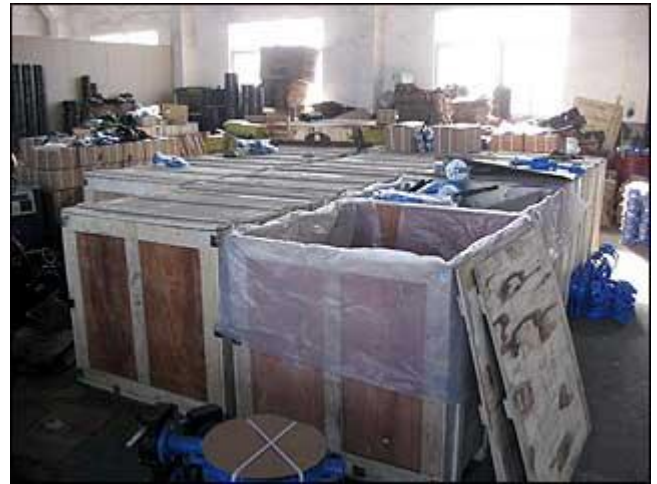
Packed goods

Expected Result	Result	Actual Finding / Comments
80% of the total order quantity must be finished and packed-order qty: 7545 Pcs	Not ok	Only 5903 pieces on site and 5443 packed in carton; details please refer to below table. 1642 (22%) not found in TJ factory

Quantity of packed products:	5443 (72%)
Quantity of finished & unpacked products:	460 (6%)
Quantity of semi-finished products:	1642 (22%) not found in TJ factory

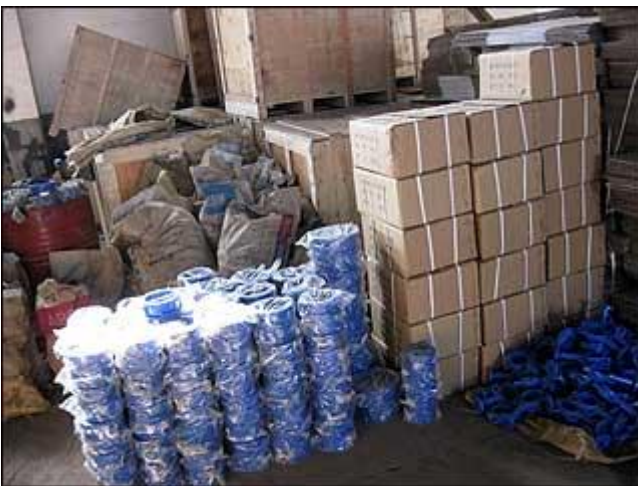
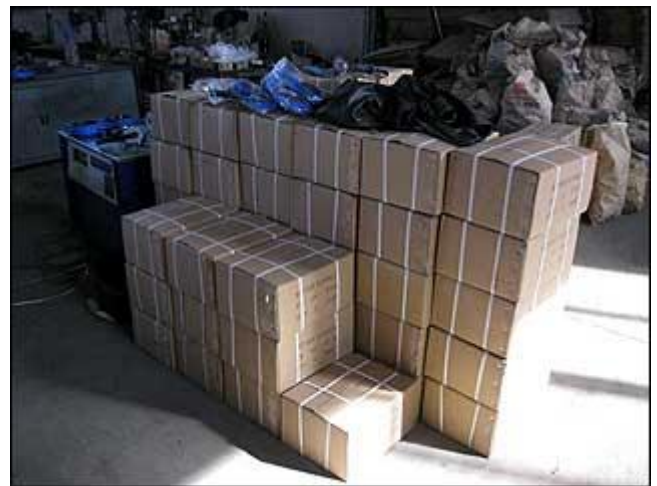
Bulk

Note: For BF 150 in bulk and they would be packed in inner box before shipment which was declared by factory;

For Check valve all in bulk on site;

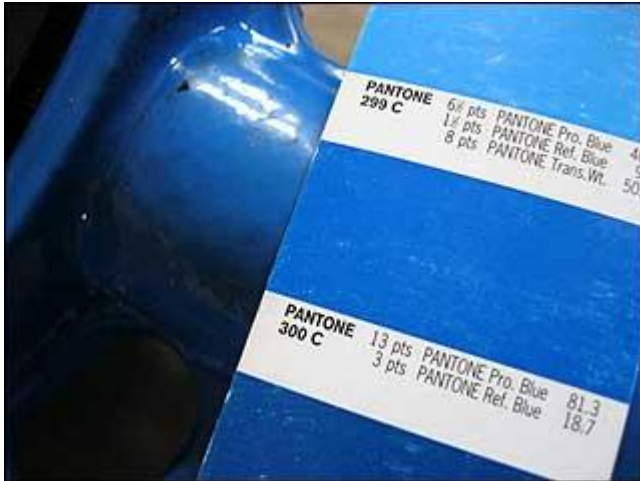
For Butterfly 300 C

1. The color compared with RAL PANTONE ,found a slighty difference ; please refer to page 4 ;
2. For item Blue DN50,found a sharp point at handle area ;please refer to page 16 ;
3. No shipping mark found during inspection ;
4. No calibration label on equipment for weight checking and hydraulic test,the test result is for reference only ;
5. No approval sample compared with during inspection ;

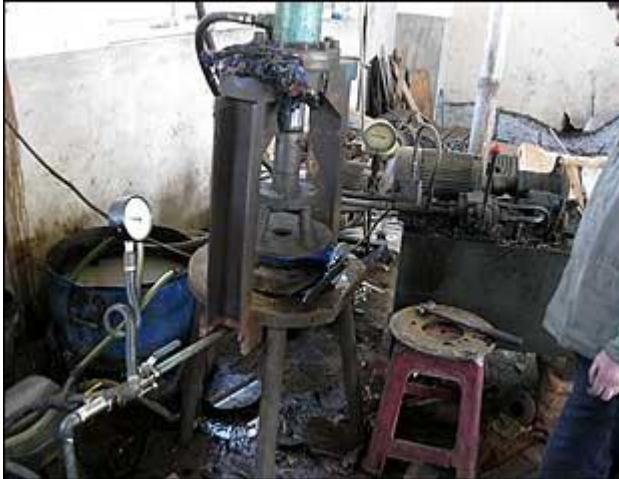
Hydraulic test -1 pc per type--20pcs	Satisfactory	Passed

<p>For butterfly valve</p>

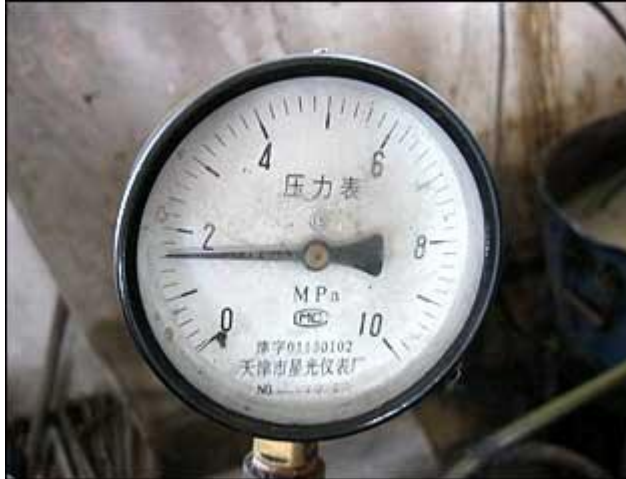
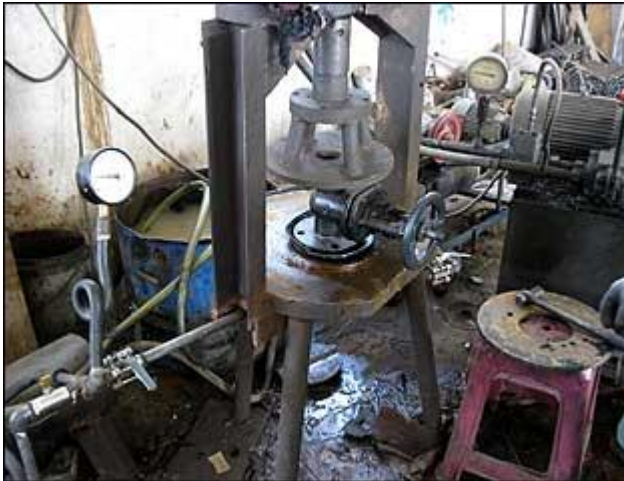
<p>For brake valve</p>

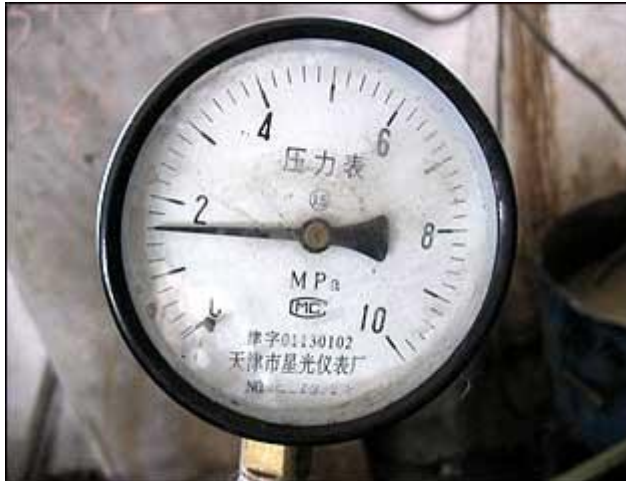
<p>For brake valve</p>

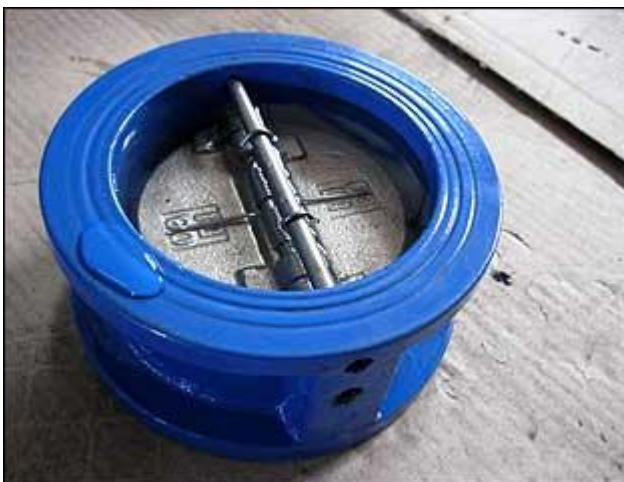
<p>For check valve</p>		
<p>Chemical analysis -1 pc per type--5 pcs</p>	<p>No chemical analysis report and equipment provided on site</p>	<p>n/a</p>
<p>If applicable , containment(impermeability) class -2pcs per type--5pcs</p>	<p>No equipment provided on site for this test.</p>	<p>n/a</p>
